<b>GPMP 2008</b>	<b>GRID SQUARE(S)</b> 101 - X 29.	<b>ARCHITECTURE</b>	<b>CONTEXT</b> 29292.									
1. Material	1/ Mudbrick.											
2. Size of materials	2/ -											
3. Finish	3/ Regular courses (2 Rows)											
4. Coursing/bond	4/ -											
5. Form	5/ Wall											
6. Direction of faces	6/ E-W											
7. Orientation	7/ N-S											
8. Dimensions	8/ 0.72 m length - 0.88 m wide											
9. Associated collapse	9/ N.A.											
10. Founds, cuts & fills	10/ N.A.											
11. Repaired	11/ N.A.											
12. Associated floors	12/ N.A.											
13. Plastered	13/ N.A.											
14. Wall core	14/ N.A.											
15. Types of brick (%)	15/ 80% mud - 20% sand. 16/ sand, mud											
16. Composition of bricks	17/ 40 x 18 cm ;											
17. Dimensions of bricks (sample of three)												
<b>Stratigraphic Matrix</b>		Abuts	Above

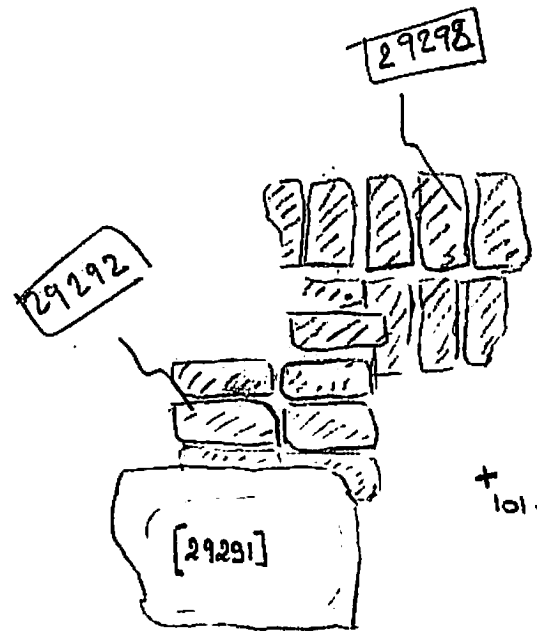
+ 101-X29

29292			29291		Abutted by	Below 29291.
	29292											
	29291											
		Bonded into										
		Contiguous with										
<b>INTERPRETATION</b>												
		Enclosing	Internal									
			External									
Reason for decay	Mudbricks wall which seems to be connected											
Indications of original dimensions	with 29290 (?)											
Indications of original functions	Stone (29291) puts on it.											
Wall which could have a return to the east (see n° 29298)												
Associated contexts:												
Context Same As:												
Drawing Nos: 2005 - 1418		Samples										
Photographs	Findings											
	Bag No.	Type										
Roll			Building Complex:									
Frames			Phase									
B-W												
CS												
DP												
CP	Site Book Pages	Checked	Initials <b>DEL</b> Date 19-11-08
