GPMP 2008	GRID SQUARE(S) 201A32	ARCHITECTURE	CONTEXT 29488
1. Material	1. Mud Brick		
2. Size of materials	2. 40 cm to 34 cm long x 20 cm to 18 cm wide		
3. Finish	3. N.A		
4. Coursing/bond	4. N.A		
5. Form	5. Mud Brick Installation.		
6. Direction of faces	6. North South East West		
7. Orientation	7. N.A		
8. Dimensions	8. 38 cm wide x 40 cm long		
9. Associated collapse	9. N.A		
10. Founds, cuts & fills	10. N.A		
11. Repaired	11. N.A		
12. Associated floors	12. 29417 foundation as a floor		
13. Plastered	13. N.A		
14. Wall core	14. N.A		
15. Types of brick (%)	15. Sandy Mud Brick		
16. Composition of bricks	16. Sand Mud		
17. Dimensions of bricks (sample of three)	17. See above

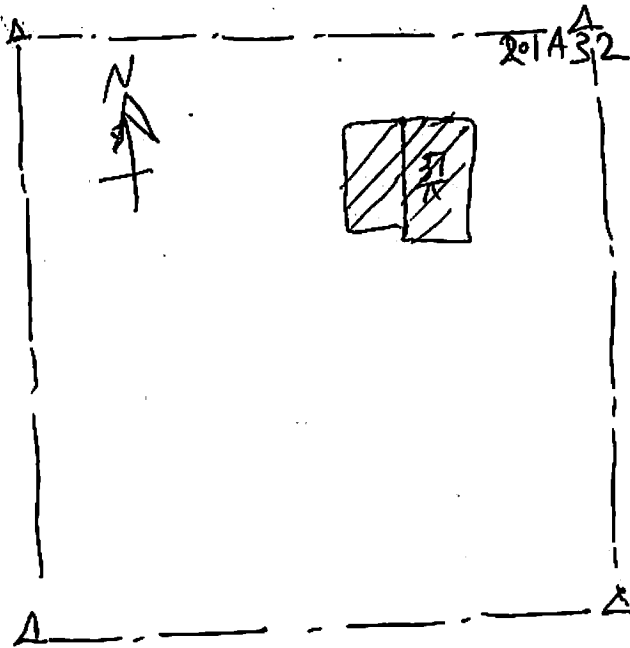
drawing# 2008-47

INTERPRETATION	Enclosing	Internal	External
Reason for decay	this feature is Mud Brick Installation May be		
Indications of original dimensions	In situ so But I don't know the main		
Indications of original functions	functions of it. ?		
this feature is need More Excavation.
