TEL DOR 19 88 field G square A.H.3.4 phase (in area): _____ LOCUS W9301 (CARD 1 OF 2)

date opened 27/07/88 level 1531 date closed 12/08/88 level _____ floor level _____ type of locus WALL

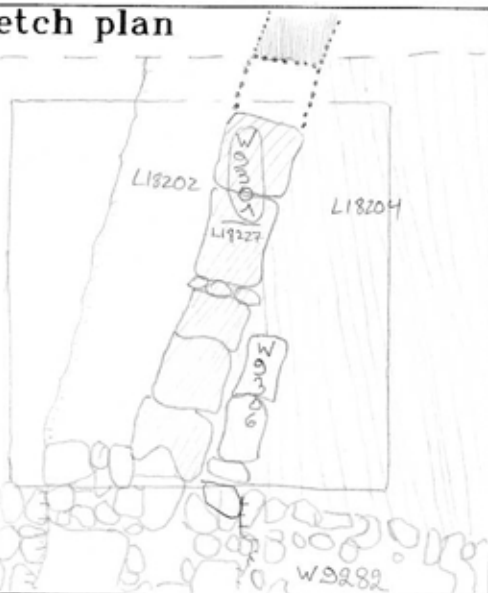
Sketch plan

POSSIBLY W9301 WAS ROBBED TO THE NORTH AS W9301 SEEMS TO CONTINUE INTO THE BALK AS A SIMILARLY SHAPED ASHLAR APPEARS ON THE SAME LINE in the bulk

▨ = W19301

.... = POSSIBLE CONTINUATION OF W19301

▨ = L18204

▨ = POSSIBLE ASHLAR IN BALK CONNECTED WITH W19301
