AREA: KKT-E+	GRID SQUARES: 201-H46	INITIALS & DATE: DCS 15 APRIL 2014	FEATURE No.: 34601
FEATURE TYPE (For example wall, staircase, bench, foundation structure, platform etc.): BLOCKING.		Full extent visible in plan: YES / <input checked="" type="radio"/> NO

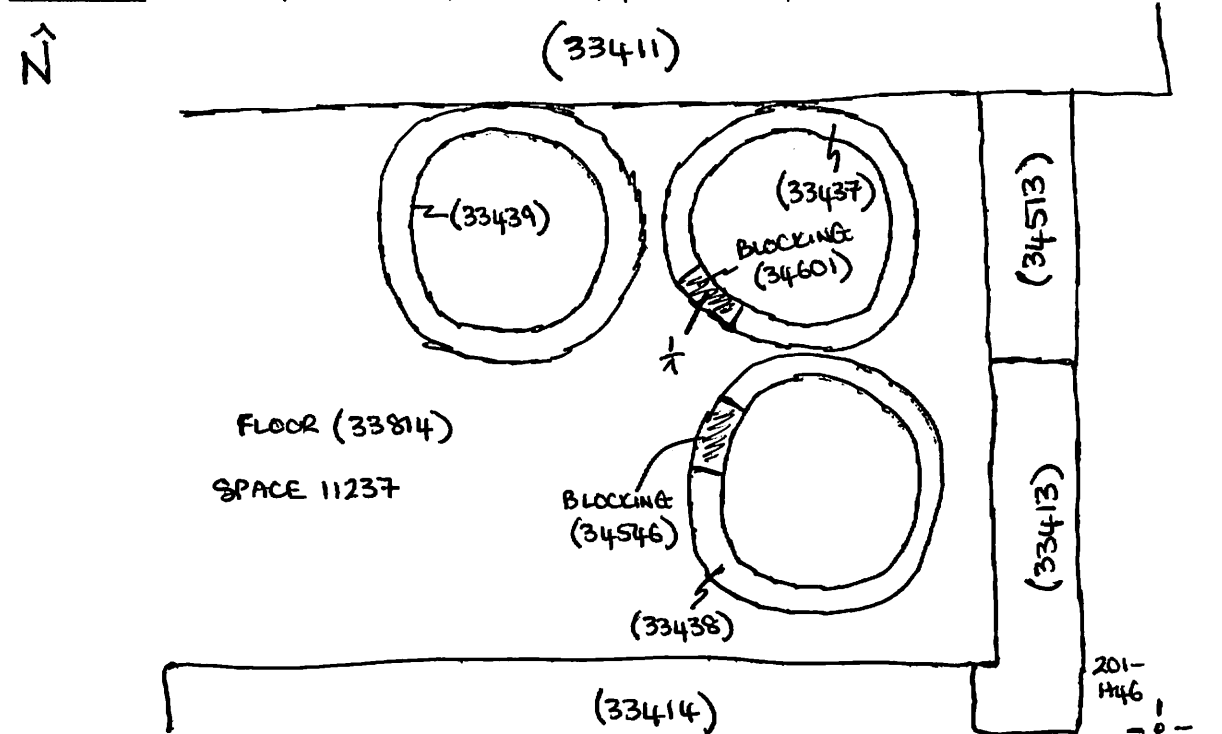
Sketch Plan - Include square numbers, North arrow, space numbers, and elevations.

1. Dimensions (in metres)	Length: 0.40m	Width: 0.12m.	Height: 0.09m
2. Type of material(s) used	SANDY CLAY, POTTERY FRAGS		
3. Coursing (form of construction)	MIXED MATERIAL. MARL BRICKS WERE PLANNED OVER THIS FEATURE IN 2012 WHICH WERE NOT VISIBLE IN 2014.

10. Size of one component	/		
11. Bonding material	NONE		
12. Excavated	Yes <input checked="" type="radio"/> No		
Mini stratigraphic matrix 		Abuts:	Same as:
		Abutted by:	Associated features:
		Bonded into:	
		Contiguous with:	
Discussion and interpretation: BLOCKING OF AN OPENING IN WALL OF SILO (33437). COMPARE WITH BLOCKING (34546) OF OPENING IN WALL OF SILO (33438).
