TEL DOR 1986 field G square A.J.3.2 phase (in sq.): 2+3? LOCUS W19.0.1.9

date opened 0.9/0.7/8.6 level 1.5.8.5 date closed 1.1/0.8/8.6 level 1.5.4.5 floor level _____ type of locus Wall

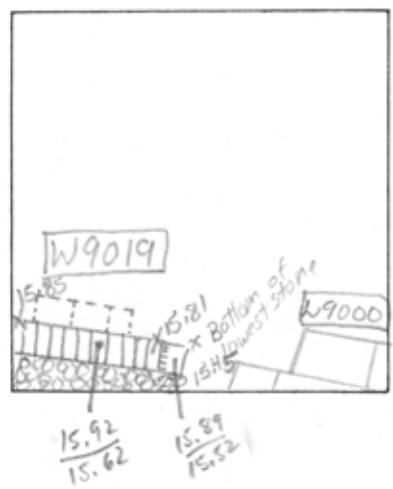
graphic description

DEFINITION/LIMITS [W9019] extends from the west baulk 27cm north of the southwest corner and runs in a southeasterly direction for about 2 meters.

CONSTRUCTION - [W9019] was constructed of 11 header stones (visible in square A.J.3.2). Only packed earth and rubble was visible under the west end of [W9019]. 4 ^{CUT} stones are lying under the east end of [W9019] and extending beyond the last header stone. ^{They seem to be part of the same wall.}

RELATION TO OTHER ELEMENTS - [W9019] was covered by the soil of [L9000]. The kurkar surface [L9012] reached [W9019] at its top. The three adjoining flat stones were at approximately the same elevation as Floor [L9012] and may have served as a threshold. Floor [L9027] reached [W9019] immediately under the flat stones adjoining it. [W9019] began to float in [L9033].

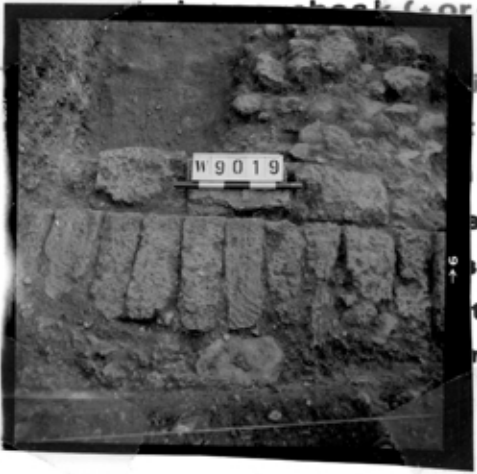
photos

PHOTOS - Three flat stones adjoining [W9019] - M7014.06. Relation of [W9019] + [L9027] M7017.09 & 1986-02-19
