TEL DOR 1988 field G square A.H.3.3 phase (in area): _____ LOCUS W9264
 date opened 20/07/88 level 15.94-15.88 date closed 21/07/88 level 15.78-15.69 floor level _____ type of locus *WALL paving stones of fl 9240
 loci above 9240 loci below 9284 sealed by _____

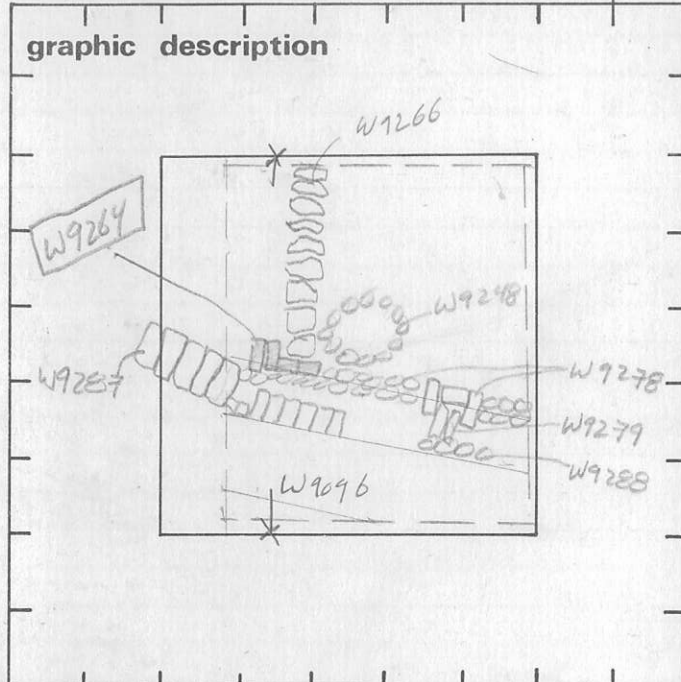
Summary:
Description: REASON FOR OPENING: CAME DOWN ON WALL WHILE EXCAVATING [L9240]
 DEFINITION/LIMITS: TWO HEADERS AND TWO STRETCHERS RUNNING PARALLEL TO [W9096], ~75cm NORTH OF IT. BEGINS ~35cm FROM WEST BULK.
 MATRIX: SANDSTONE ASHLARS ~LENGTH 90cm, WIDTH 25cm, HEIGHT 15cm
 REASON FOR CLOSING: WALL REMOVED TO EXCAVATE [L9289] BELOW WALL
 RELATIONS TO OTHER ELEMENTS: FLOATS ABOVE** AND PARALLEL TO [W9278]. DOES NOT REACH [W9248]. [L9240] COVERS W9264. TRENCH [L9247] REACHES (BUT DOES NOT ROB?) W9264. [L9289] IS SEALED DIRECTLY BELOW WALL - WALL CUT [L9264]

* L9264 = the paving stones of the Roman street (= fl 9240)
 So fl 9229 represents the subflooring of the paved area.
 L9264 probably does reach L9247 (= L9248) the Sump & are contemporary (see photo to left)
 May have covered Sump L9247 (+ W9248)
