TEL DOR 19 89 field G square AE3.2 phase (in area): LOCUS L9389  
 date opened 13/07/89 level 16.78-16.70 date closed 19/07/89 level 16.53 floor level A 16.60-16.60 B 16.57-16.53 type of locus RUBBLE + Z SURFACES  
 loci above 9370 9371 loci below sealed by

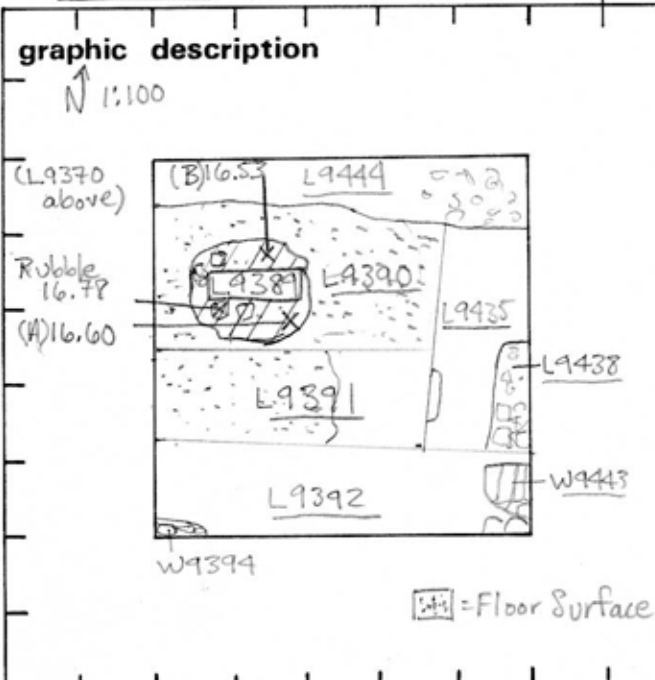
**DEF./LIMITS:** [L9389] IS SURROUNDED ON ALL FOUR SIDES BY [L9390] A FILL DOWN TO A FLOOR.

**MATRIX:** CHUNKS OF MARBLE & SANDSTONE RESTING ON SURFACE A (CRUSHED KURKAR), BELOW WHICH IS SURFACE B (CRUSHED POTTERY)

**RELATIONS:** [L9389] IS DIRECTLY BELOW FILL [L9370]. LOCI BELOW NOT YET DETERMINED. PILE OF STONES/MARBLE WAS RESTING ON A

KURKAR SURFACE WHICH MAY POSSIBLY BE THE SAME SURFACE AS THE ONE IN [L9371]. SOIL BETWEEN SURFACE A & B WAS STERILE SO LOCUS NUMBER NOT CHANGED. SURFACE B (CRUSHED POTTERY) IS IDENTICAL IN MAKEUP AND AT APPROXIMATELY THE SAME LEVEL AS THE FLOOR IN [L9391]. IT IS ONE OF THE RESURFACINGS OF THE FLOORS THAT COVERED THE HYPOTHESIZED ROOM. THE RUBBLE (STONES & MARBLE) MIGHT HAVE BEEN PART OF THE ROOMS WALLS WHICH WERE ROBBED OUT.
