| <b>Locus</b><br>W 9839 | <b>Dor</b> 19 <sub>912</sub> | <b>Fld</b> G <sub>1</sub> | <b>Sq</b> AG33 | <b>Loc. type</b><br>Rubble WALL |

**Summary**

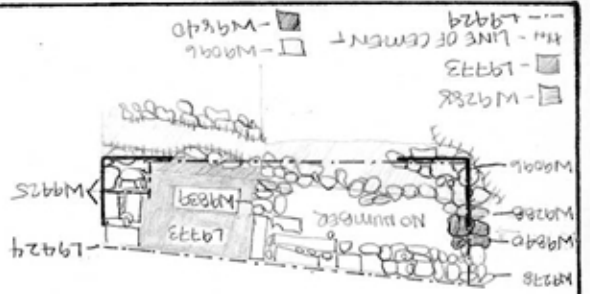
Sketch plan

**Matrix:** 8-10 STONES AND COBBLES, RANGING FROM ~10cm TO 45cm IN DIAMETER, RUNNING NORTH TO SOUTH. IT IS 2 COURSES HIGH.

**Relations:** W9839 may be cut by W9096 AND IS BONDED WITH W9278 WHICH RUNS EAST TO WEST. TWO REMAINING STONES BELONGING TO W9286 FLOAT ON TOP OF THE HIGHEST COURSE OF W9839 AT ITS JUNCTION WITH W9096. L9773, BEING A ROBBER TRENCH, MAY HAVE ROBBED OUT A PORTION OF W9839 AND/OR W9278. THE UN-NUMBERED LOCUS TO THE WEST MAY BE A SECOND ROBBER TRENCH IF IT IS A CONTINUATION OF THE WALL AND LOCUS COMPLEX OF W9278 AND W9286 WHICH ENTER AG33 FROM AH33 TO THE WEST, UNTIL THIS AREA IS EXCAVATED, ITS RELATIONSHIP WITH W9839 WILL REMAIN UNCLEAR. W9839, ALONG WITH W9840 AND W9278 MAY BE OF THE SAME CONSTRUCTION PHASE AS W9425. ALL ARE IN ALIGNMENT AND ARE OF SIMILAR CONSTRUCTION. W9839 WAS COVERED BY L9424, BUT NOT SEALED BY IT; 9424 may have robbed upper courses of W9839.

**Additional Observations/Value:** W9839 IS PROBABLY A CORNER TO W9278 AND OF PERSIAN CONSTRUCTION AS WELL IT HAS HIGH VALUE.
